Work Placement with Cliveden Conservation, 1st – 12th July 2019

The Mosaic Floor Conservation Project at Cliveden – Lifting the floor from site

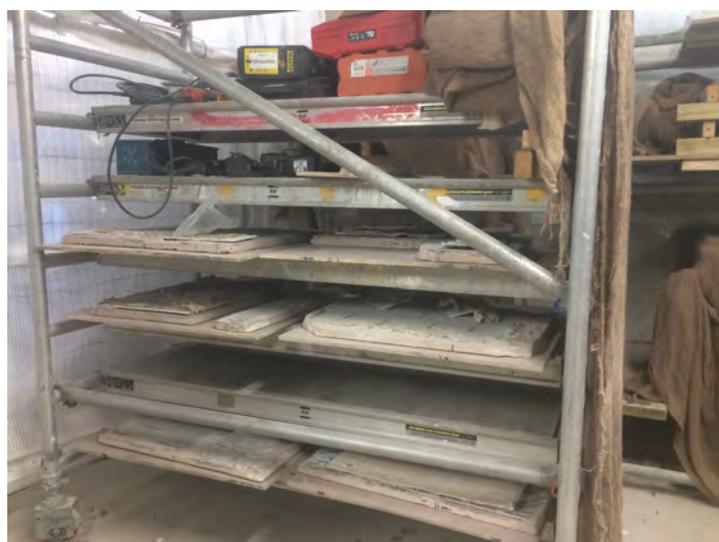
Prior to my arrival, the mosaic floor had been painstakingly lifted from its site in clearly referenced sections, carefully transported and was now being stored on purpose built storage racks within the mosaic conservation workspace. The stage of work in progress involved the removal of the cambric and foam-board facing materials, the cleaning and fixing of missing and displaced tesserae and then grouting, on a section by section basis.

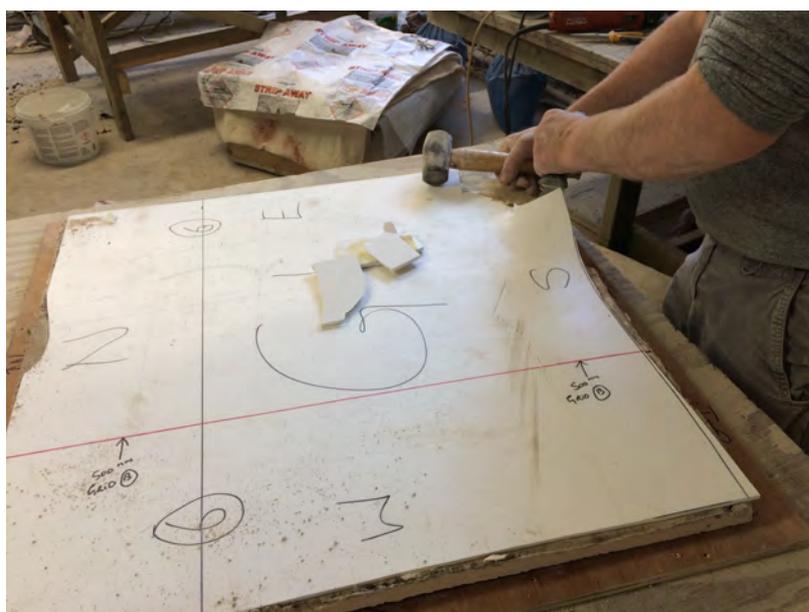
In the workshop, I met the team of conservators that were working on the sections of mosaic floor, starting with Adrian. Adrian was tasked with the removal of the foam-board and cambric facing from the mosaic, one panel at a time. The cambric had been bonded onto the surface of the mosaic with PVA and the foam-board secured on top of this with a thixotropic contact adhesive to ensure its security during the removal process on site. Back in the workshop, it proved difficult to remove these facing layers. Adrian called upon a team member to assist each time a panel needed to be lifted from the “to do” rack onto his work bench. I did not witness the stage of the workshop process that took place before this one, which was the removal of old mortar and detritus from beneath the mosaic and setting each panel into a fresh lime mortar bed.

All the panels had been carefully referenced and the first job was to transfer the reference information onto the edges of the panel with marker pen. Next, Adrian scored the foam-board and then used a hammer and scraper to ping it off. In theory, the cambric should then have sponged off but in fact it resisted being dissolved with water. We discussed this and surmised that the thixotropic adhesive had leached into the

cambric – we could see yellow staining to the fabric that supported this conclusion. Once Adrian succeeded in removing the cambric, it was then necessary to gently abrade away deposits of adhesive from the surface of some of the marble tesserae.

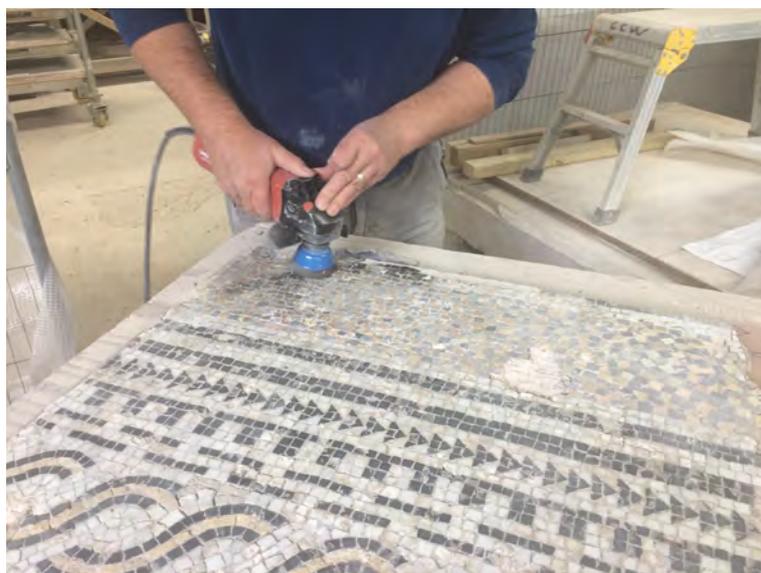
Adrian returned each panel, together with any loose tesserae from that panel bagged and referenced to the appropriate rack for the next stage of work to be carried out. Before doing so, he photographed the panel and made a note in the ledger of the time spent on the facing removal stage for it.

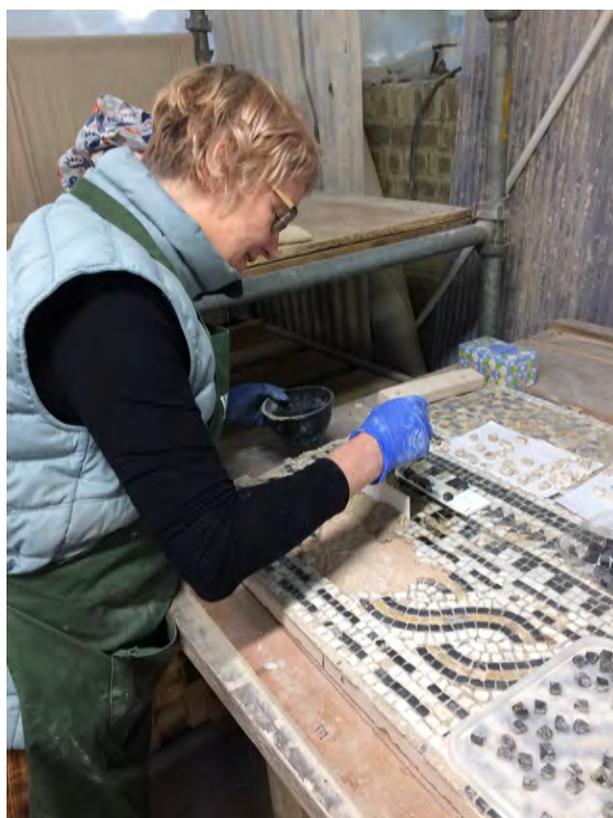
I was involved in the next part of the process, guided by Amelia. The first panel that I was presented with had a series of spaces where tesserae were missing. The preparation involved chiselling out the lime mortar in these spaces to a suitable depth right up to the adjacent mosaic pieces followed by fastidious cleaning and sorting of the salvaged tesserae. The mortar bed had to be kept damp all the time so that freshly mixed mortar would make a good bond with it.

Unsurprisingly, the chiselling of the mortar prompted further tesserae to loosen, so that the spaces to be filled kept growing. When the preparation work was finally complete, I began recreating the missing areas of mosaic using a combination of salvaged tesserae as far as possible and newly cut stone when required. All this work was documented and the time spent carefully recorded.

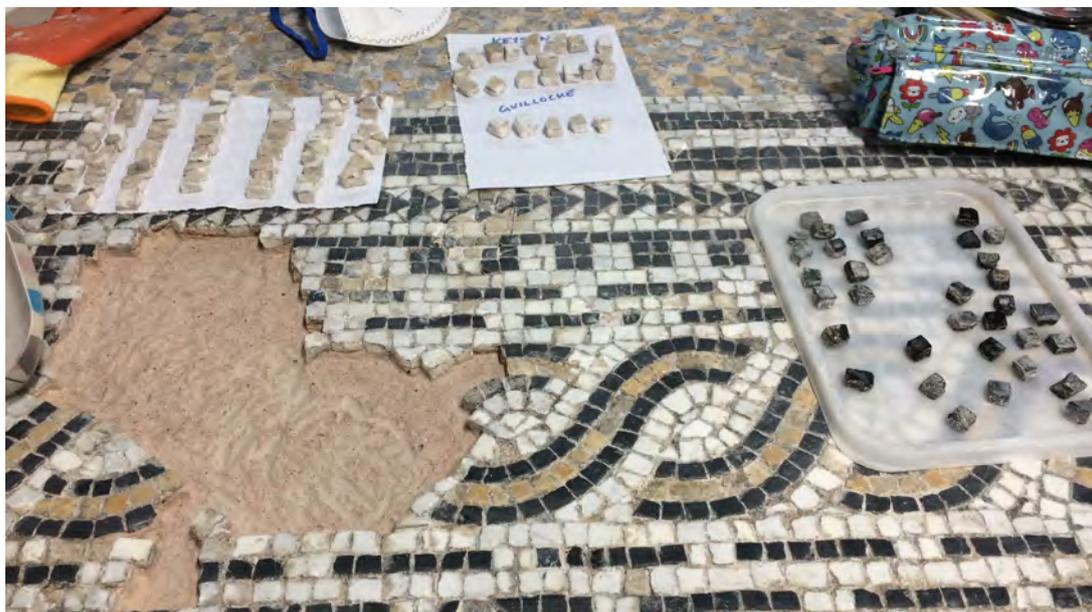
We used a hammer and hardie for cutting lengths of sawn new stone down to size. The hardie was a bench top version, unlike to hardies I have used previously. Following Amelia's advice, I had taken a good selection of small hand tools with me, which included side-biters for further trimming the tesserae and painter's palette knives that were perfect for mixing and applying small quantities of mortar. We used a specialist mortar "Adhere Cal" by SecilTek, formulated exclusively from natural hydraulic lime for the restoration sector. I had a set of wax modelling tools with me that proved useful as 'nudging sticks'. On-the-spot improvisations, such as making paper templates and creating curved mini retainer walls out of foam-board, held temporarily in position with clay, created helpful solutions within the process.
